Manhole Inspection Summary

Manhole # S37YY_006MH

Location Address: **501 33RD ST**

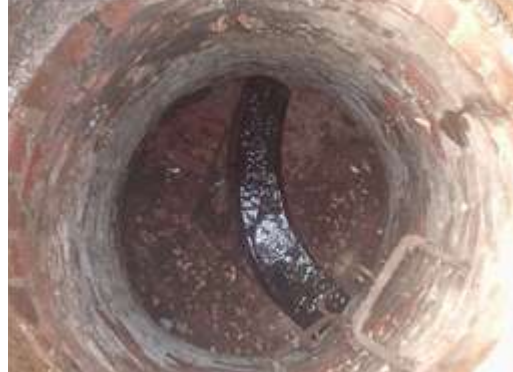
Top View

Corroded steps. Evidence of surcharge - Bench debris. Channel debris.

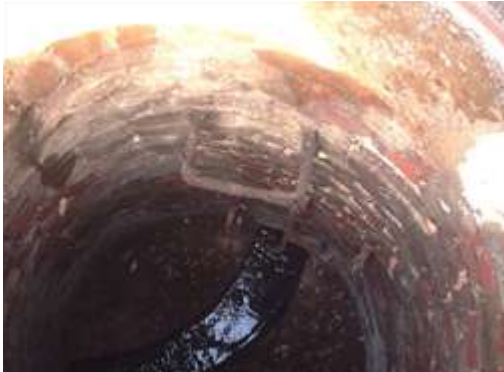
Defect

Frame leaks. Frame offset. Adjustment deterioration and infiltration. Corbel and Barrel infiltration - other side.

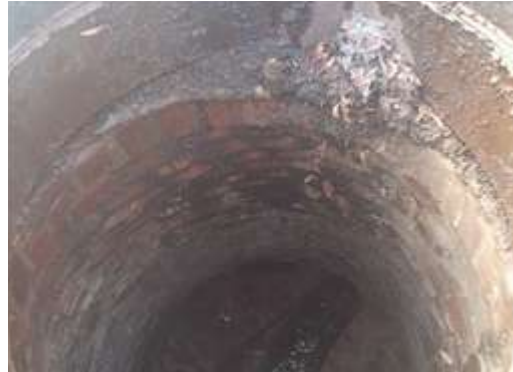
Defect

Frame leaks. Frame offset. Adjustment deterioration and infiltration. Corbel and Barrel infiltration.

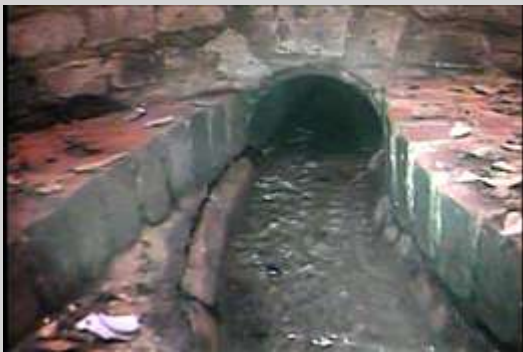
8 in. Circular Gravity Sewer Pipe Out @ 12 O'Clock

Channel deterioration.

Deposits: ☐ None ☒ **Mud** ☐ Sludge ☒ **Debris** ☐ Grease

Silt Depth: **1** (in.) Deposits Extent: **Light**

Infiltration: **Evidence** Pipe Seal Cond: **Unknown**

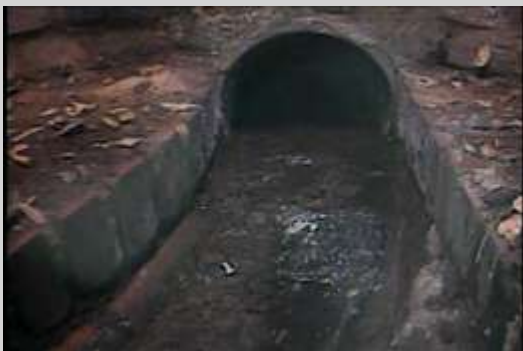
10 in. Circular Gravity Sewer Pipe In @ 5 O'Clock

Deposits: ☐ None ☒ **Mud** ☐ Sludge ☒ **Debris** ☐ Grease

Silt Depth: **1** (in.) Deposits Extent: **Light**
